R61APB769-32

PROJECT VULCAN RESEARCH and DEVELOPMENT

PROGRESS REPORT NUMBER 32

**CONTRACT DA - 19 - 020 - ORD - 5455
DECEMBER 1, 1961 - JANUARY 31, 1962
BOSTON ORDNANCE DISTRICT
DEPARTMENT OF THE ARMY**

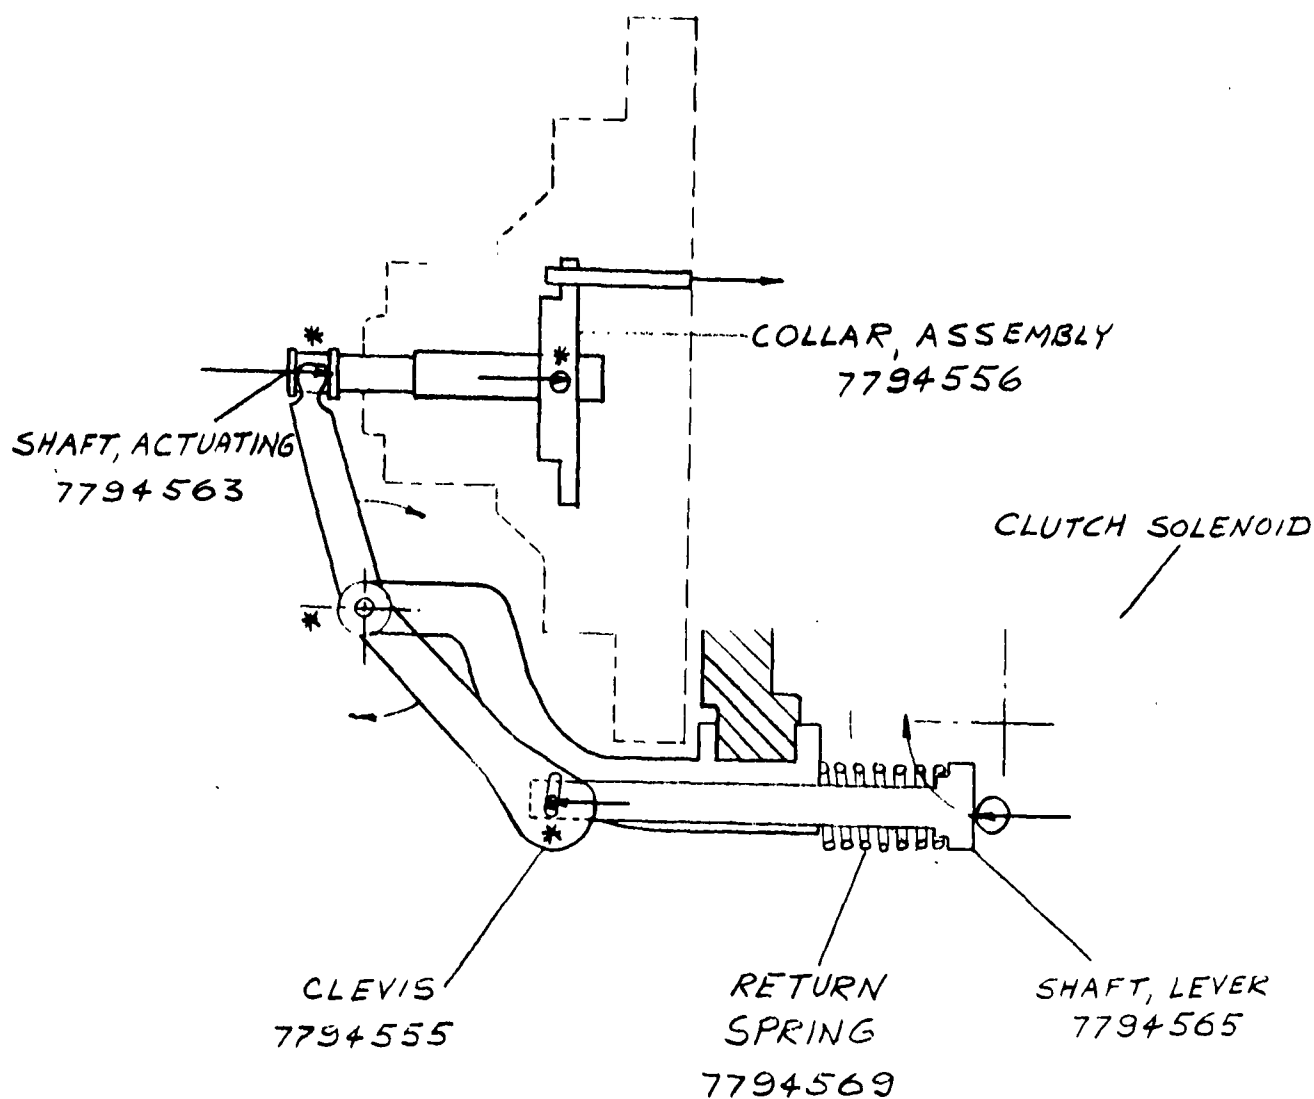
Figure 3-1. Clutch Actuation Linkage

The difficulty lies in the fact that the spring return force in the linkage is being applied at the wrong location, i. e., on the shaft lever 7794565. In addition, to impart a turning moment on the clevis 7794555 there is required a slot on the clevis to transform the axial force from the lever shaft to a turning force. Finally the tolerances are additive between the various components in the clutch linkage, especially between the clevis and the actuating shaft 7794563. These three conditions all add up to a situation in which there is a glaring lack of control of the pin and collar in the present design. This is illustrated in Figure 3-1. Those linkage connections designated with an asterisk (*) are points where tolerance conditions are unavoidable and detrimental to the linkage function. To move the collar assembly from its re clutch to its declutch position it is desirable to have these linkage junction fits closed tightly. Note, however, that when the clutch solenoid imparts a force to the lever shaft, the return spring merely serves to keep the lever shaft tight against the solenoid pin. Although the linkage system is responding to a force signal, the only forces which are available to close up the various junction fits are the minute inertia forces on the parts. These are believed easily overcome by gun vibration forces. The worst junction point is the clevis connection to the lever shaft. The clevis has a slot in which rides a spring dowel pin fastened to the lever shaft. Rotational motion of the clevis results from a camming action of the pin in the slot. The change of angle of the slot, occurring when the clevis rotates, results in practically no resistance to forces (such as gun vibration forces) in the opposite direction. All of these situations combine to create a lack of control on the pin and collar (the key part in the declutching operation) during its travel from the re clutch to the declutch position. This lack of control is shown in Figures 3-2 and 3-3.

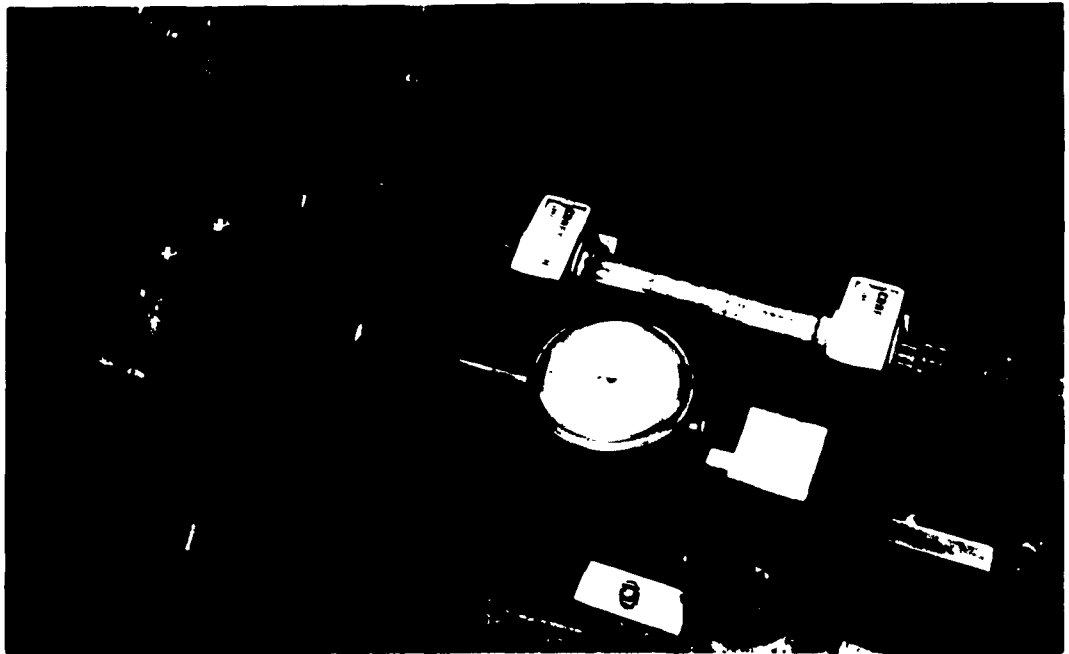
Figure 3-2. Lack of Control on Pin and Collar Linkage

In Figure 3-2 the feeder gear has been removed and the pin and collar stopped part way in its travel by applying a wedge between the feeder housing and the solenoid pin. It is possible in this position to move the pin and collar back and forth .040" as shown on the dial indicator in Figure 3-3. Layouts show a maximum allowable back and forth movement of .058 in the extreme conditions.

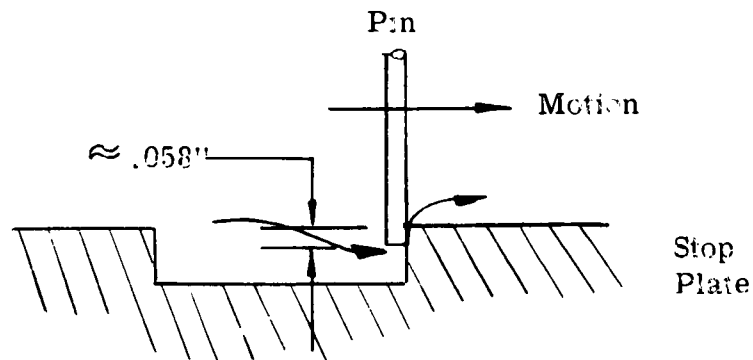
Figure 3-4. Sketch Showing Approximate Depth Pin Could Engage Slot End and Slip Out After Starting Clutch Action

Figure 3-4 shows what this means. On some occasions the pin could enter a stop plate slot and while at a depth of 0 to .058" strike the slot end. After clutch actuation has commenced vibration could shake the pin out of the slot thus interrupting the clutch actuation allowing the traveling lock ring lugs to be jammed between the gear drive lugs and the stationary housing lugs. This .058" looseness must be eliminated.

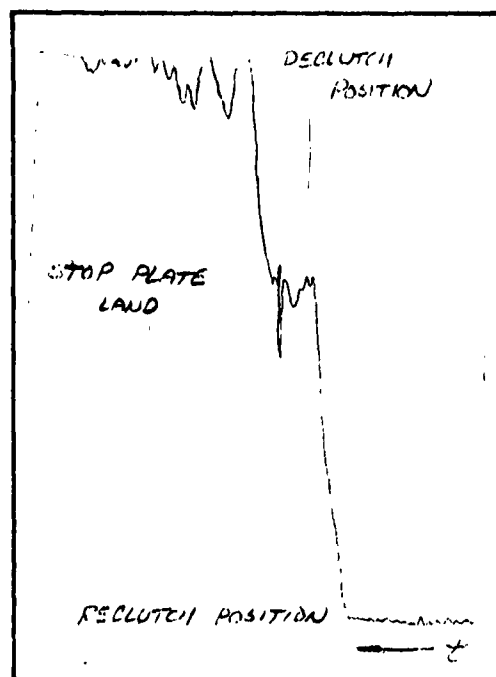
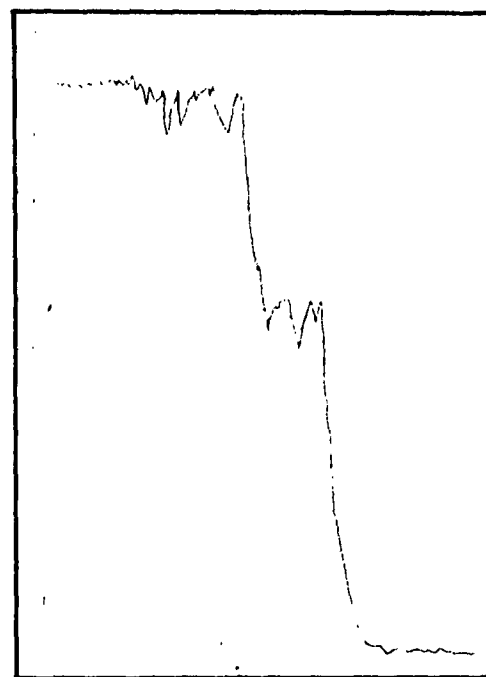
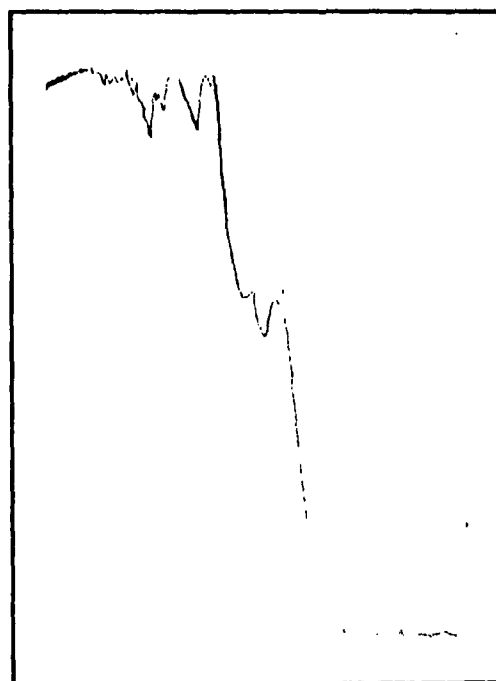
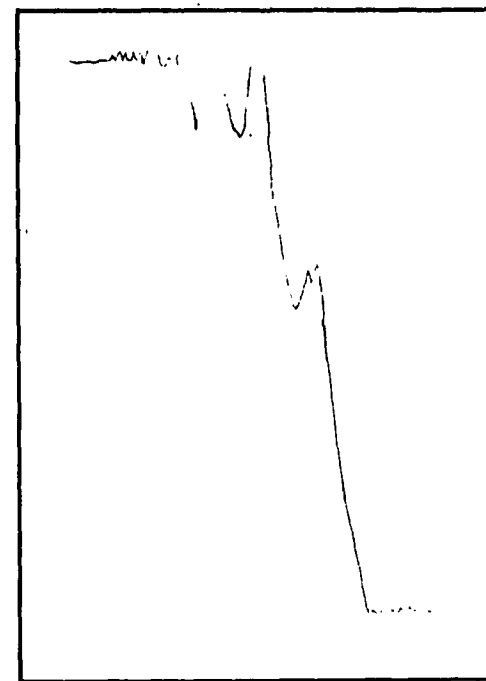
Figure 3-9 Typical Pin And Collar Motion On Proposed Clutch Design

Figure 3-9 shows four typical oscillograph traces of displacement vs. time for the actuating shaft in the present clutch. They are to be compared with four typical oscillograph traces (Figure 3-10) of the actuating shaft in the proposed clutch linkage. Note the reduction in bounce obtained where the pin on the pin and collar has struck a land between the slots in the stop plate.

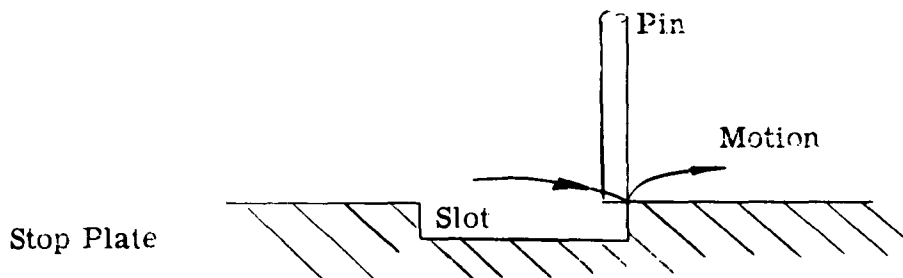
Figure 3-11. Statistically Remote Corner to Corner Condition of Pin on Slot End

The proposed design was compared with the existing design by cycling the same feeder clutches, with both methods of clutch actuation, on the bench tester. At the beginning of each test a new pin and collar and a new stop plate were placed on the test feeders to eliminate the possibility of wear on these parts causing declutching malfunctions. Feeders with the new proposed design consistently averaged about one malfunction in 600 declutching operations as opposed to about 2 out of 300 for the existing design. It is believed that it is still remotely possible to get a malfunction if the clutch is actuated under exactly the right circumstances such that the pin on the pin and collar strikes the stop plate slot end corner to corner as shown in Figure 3-11. This condition may be enough to start clutch actuation before the pin slips free to set up a declutching malfunction. Very little wear is caused during malfunctions of this nature and its occurrence is so statistically remote that a solution to this situation is not warranted.

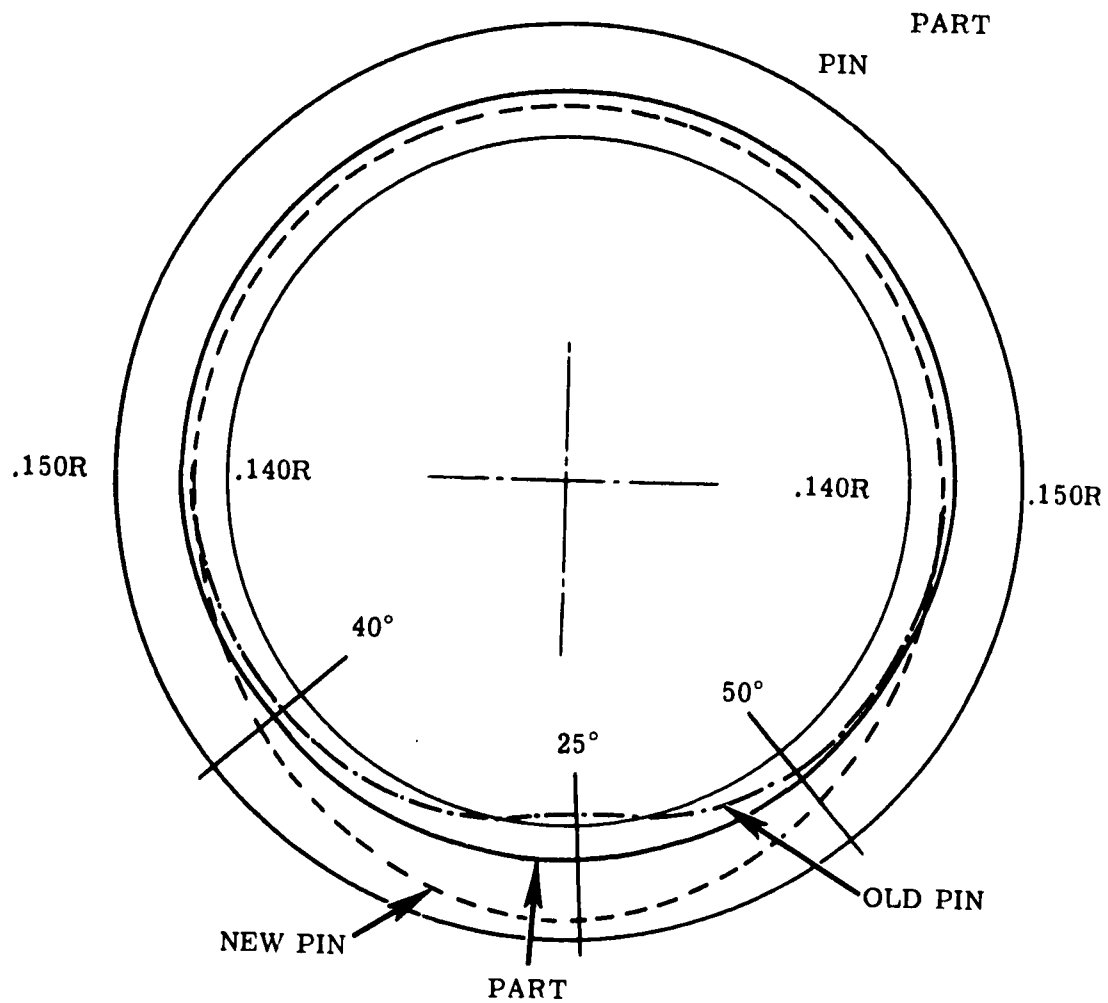
Figure 5-9. Old and New Pin/Part Relationship

One of the major problems which was encountered in molding the inserts was an out of round condition of the firing pin insulator I. D. The I. D. varied from a minimum of .283 to a maximum of .288 inches (drawing dimension .282 + .003). To make the core pin, shrinkage of the plastic was estimated as .002 inch therefore the core pin was machined to .2863 inch. By sectioning the resulting parts and examining them on a shadow graph comparitor it was discovered that the plastic was .008 inch larger on a side than the core pin except for the area under the insulator flat (see Figure 5-9). This area showed a shrinkage up to .004 inch. To compensate for this shrinkage a pin with a bump on it was manufactured as shown in Figure 5-10. With this pin the parts were produced to the drawing tolerances.

A second problem which has been encountered is the poor concentricity of the .282 + .003 diameter with the .100 + .002 diameter. Figure 5-9 shows that this condition is the result of the part being distorted. It is felt that this distortion is caused by the placement of the molding gate. To eliminate this problem the gate will be moved to the thin (flat) section of the insert. It must be pointed out that the concentricity is within drawing tolerances when the insulator is inserted in the bolt body.
